## APPLICATION OF CONDITION ASSESSMENT PRINCIPLES TO THE BLACKMAC SEWER

**Alaster Goyns****Owner Pipeline Installation and Professional Engineering Services CC****ABSTRACT**

This approach was applied to a 7.8 kilometre section of the Blackmac outfall sewer across the Cape Flats, consisting of 800 to 1 000 mm diameter coated fibre cement pipes installed during 1983. Most of the upstream 3.8 kilometres had sufficient capacity for the required flow and adequate structural integrity. The downstream section had been de-commissioned, had inadequate capacity and sections were severely corroded. A remaining life analysis indicated that sections had collapsed. At the end of 2016 contracts for rehabilitating and replacing sections of this sewer were awarded.

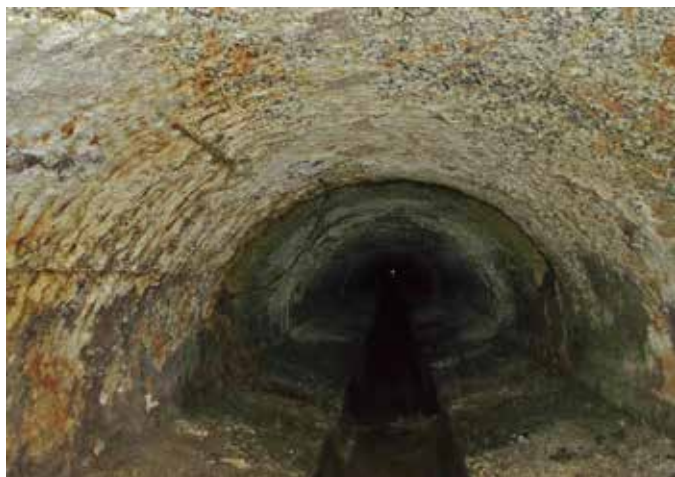
**FIGURE 7:** Severe corrosion just downstream N2

- The manhole immediately south of the N2 was accessible and it was established that only a short section at the inlet and outlet to this road crossing was severely corroded (see Figure 7).

2. The ends of the sewer reach under the N2 needed urgent attention and consideration was initially given to letting this out as an advance contract.
3. Between the N2 and the siphon the existing sewer had the capacity for future flows if cleaned and lined and the structural condition was reasonable. However the ease of access and shallow excavations made the choice of rehabilitation or replacement an economic one.

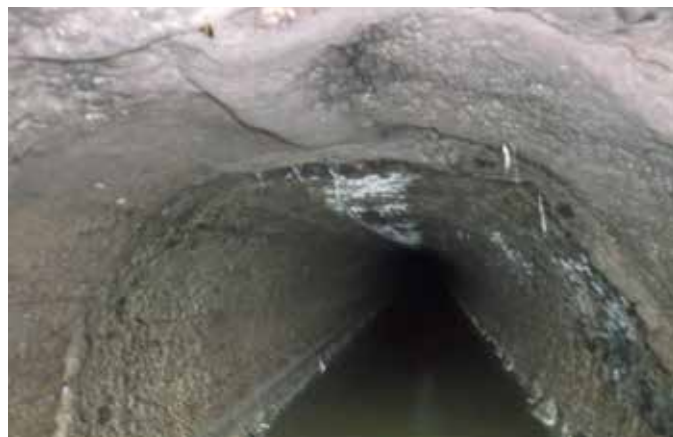
The swell of up to 44 mm on the 900 mm ND FC pipes indicates that at least 11 mm of material had been corroded away indicating an original wall of between 32 and 38 mm. On the basis of this it was taken that the original pipes were series '3' pipes as per SABS 819 which would be equivalent to 72 D load pipes in terms of the concrete pipe specification. With a protective coating these would be adequate to take the external loads, but once the coating fell away and the pipe wall started corroding the residual strength of the pipes would be compromised.

**FIGURE 8:** Swelling due to corrosion of FC pipe
