DEBRIS WALLS – LEARNINGS AND SUCCESSES OF ETHEKWINI MUNICIPALITY

GEOFF TOOLEY
eThekweni Municipality, Durban, KwaZulu-Natal, South Africa, 4001

ABSTRACT

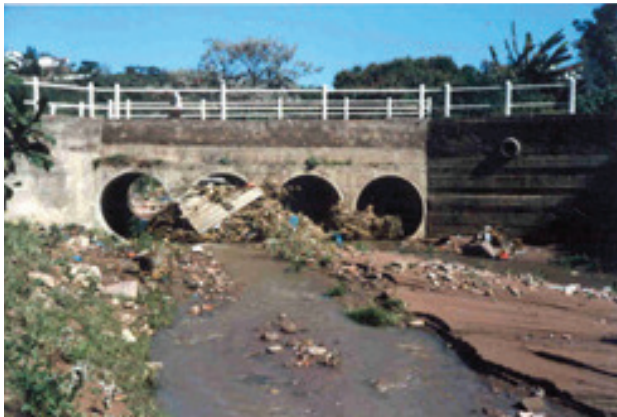
FIGURE 1 Typical blockage of a multicellular pipe culvert after a storm event

The blockage material is normally litter in the form of plastics, paper, fridges, tyres, mattresses as well as a lot of vegetation which is normally alien vegetation eroded out of the banks of the streams. See figures 1, 2 and 3.

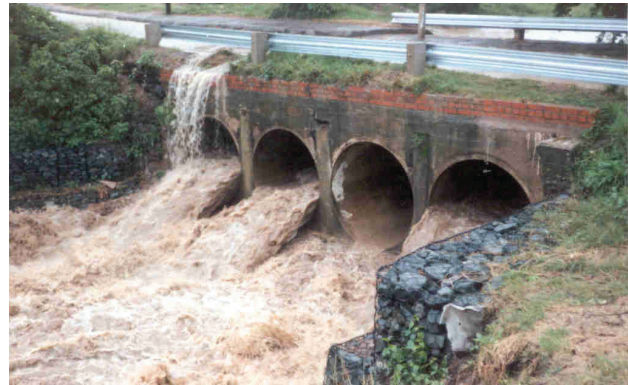
FIGURE 2 The downstream view of the multicellular pipe culvert in Fig.1 during a flood flow showing the reduced flow capacity due to the blockage of the culvert

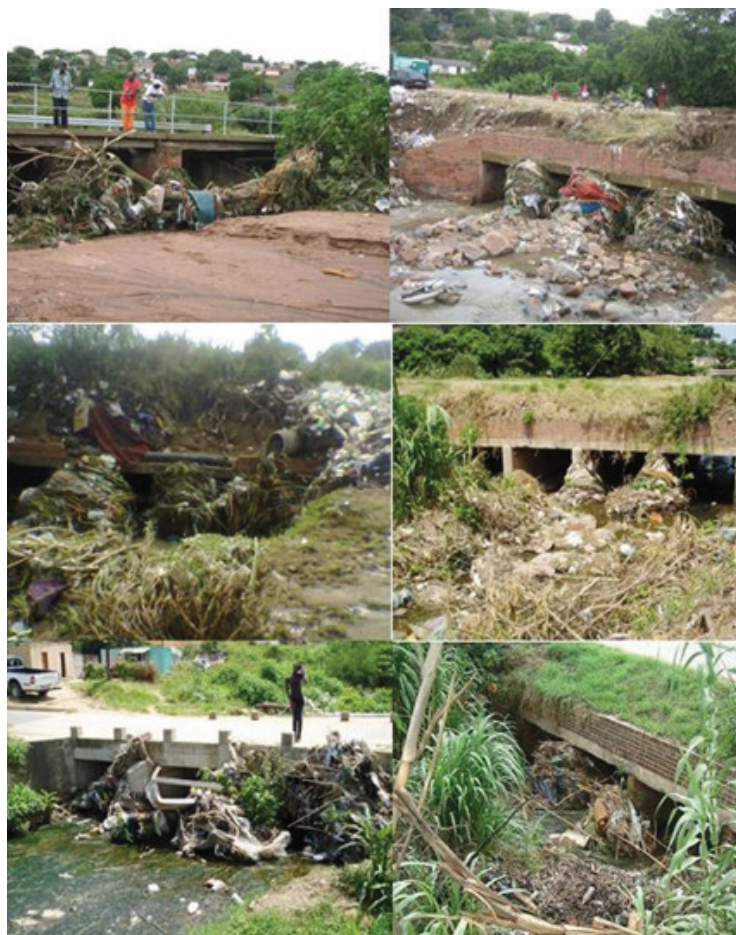
FIGURE 3 Typical blockages of multicellular box culvert crossings - notice the large amount of alien vegetation forming the blockages

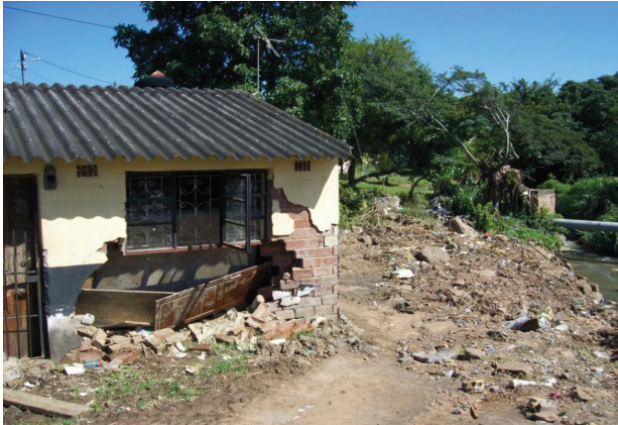
FIGURE 4 This house is situated upstream of a crossing that blocked and the upstream depth of water caused the house wall to fall inwards

The blockages result in damage to the roads and associated infrastructure as well as the houses situated upstream and downstream of the road crossings as seen in figures 4 and 5. The flooding and damage of the road crossings also causes disruption to traffic and thereby to the communities

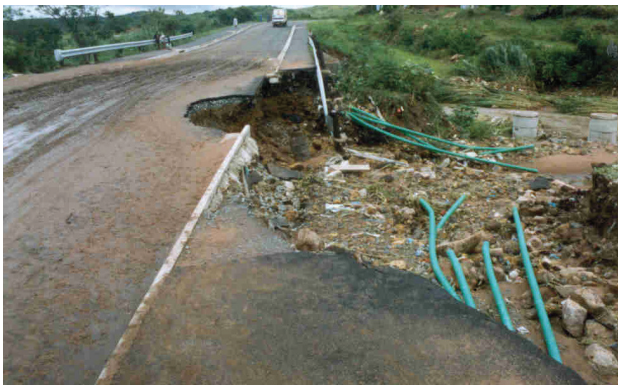
FIGURE 6 The overtopping of the culvert crossing due to a blockage caused damage to the road and services

using these roads as seen in figures 6 and 7. This often results in increased transport costs for communities which can be critical to those living on the breadline.

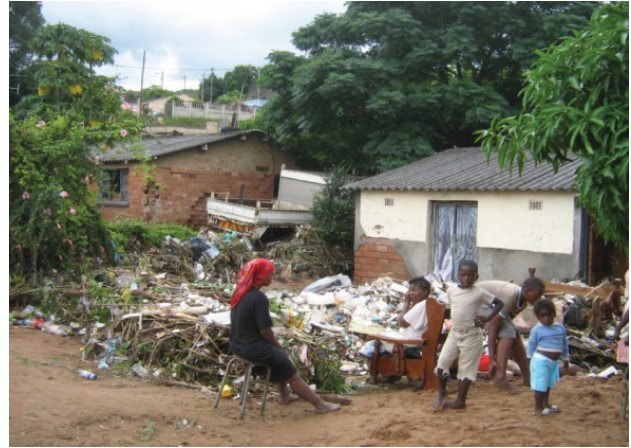
FIGURE 5 The debris deposited upstream of a blocked culvert crossing

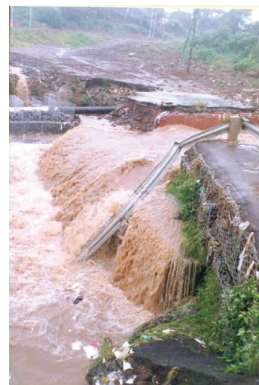
FIGURE 7 Blockages and overtopping can mean that the road is impassable

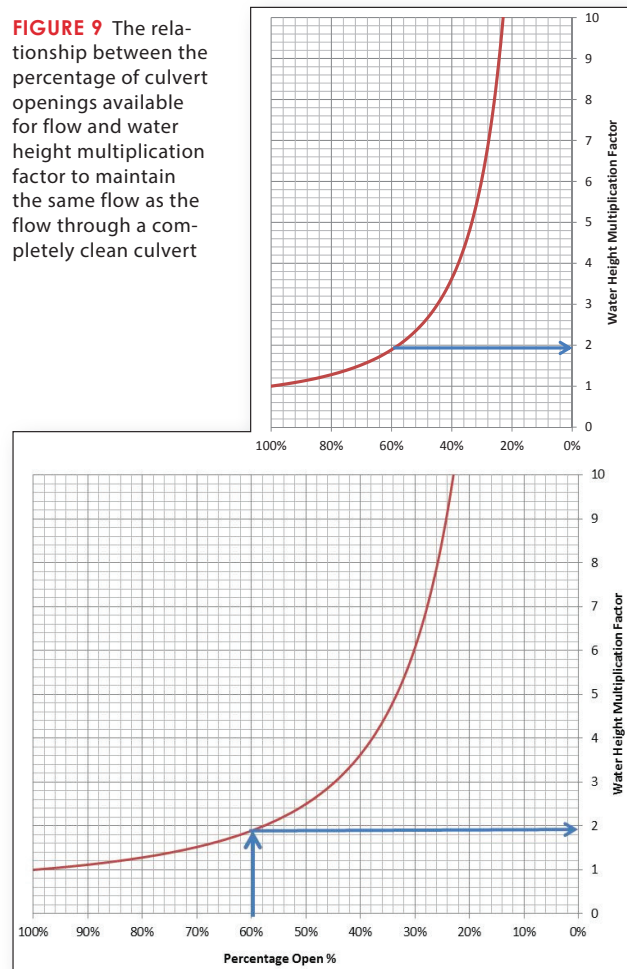
FIGURE 9 The relationship between the percentage of culvert openings available for flow and water height multiplication factor to maintain the same flow as the flow through a completely clean culvert

Using equation (1), the relationship between the reduction in culvert opening and the subsequent increase in upstream water head required to maintain the same flow through the culvert is determined and depicted in figure 9.

The curve in Fig 9 gives an approximate of the change in height of the upstream water level should debris get caught on the centre walls of the culvert crossing and reduce the effective area of the culvert. For example, assuming the flow rate remains the same, if the culvert

opening is reduced to 60%, the height of water upstream of the culvert will need to increase to 1.9 times the original height when the culvert was clear i.e. If the clear culvert flow height was 2m then the water height would rise to 3.8m above the invert of the culvert. If the height of the road crossing over the culvert was less than this height it would mean that the road would be overtopped and damage would occur.

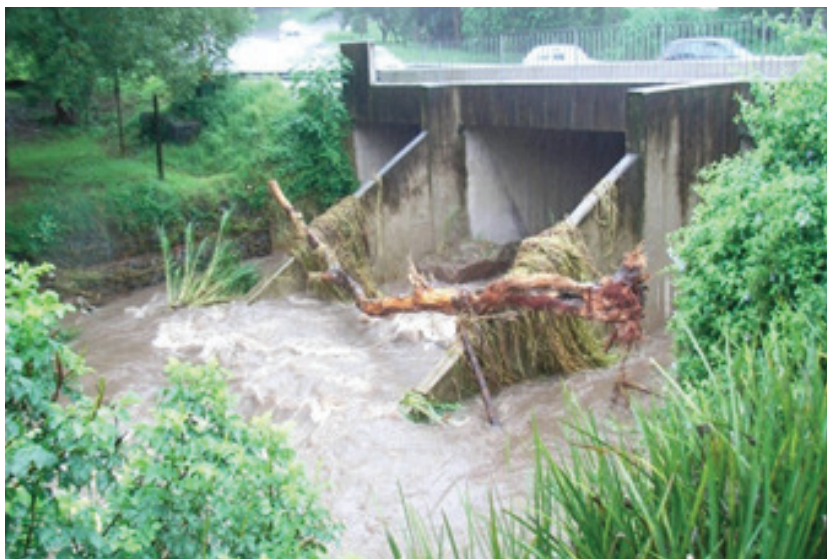
FIGURE 10 Blair Atholl Road culvert

These crossings have sloping debris walls installed which abutted the centre walls of the culvert. (See figures 10 and 11) The idea behind this method was that large debris would be forced up the sloped walls leaving the flow area open for the flood flow. This worked with respect to the large tree trunks washed down the river. However the vegetation and litter washed down the river still wrapped around the front face of the debris wall thereby restricting the flow area of the culvert. The principle of the conservation of momentum results in the water flow direction rotating towards 90 degrees to the front face of the debris wall. This means that the debris is pinned to the debris wall rather than being forced up the slope of the debris wall.

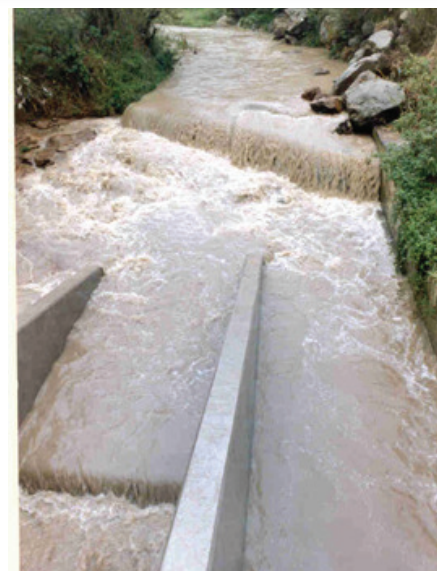
FIGURE 11 Bulbull Drive culvert

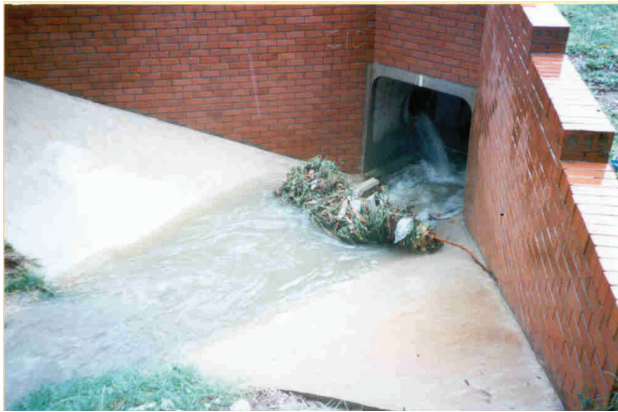
FIGURE 12 Dipdale Road culvert with debris walls

The first attempt at this methodology was the application at Dipdale Road where small debris walls were installed in the headwall to a single cell culvert as depicted in Figures 12 and 13. The installation was monitored for a number of years and the decision was taken to install some debris walls on larger culverts.

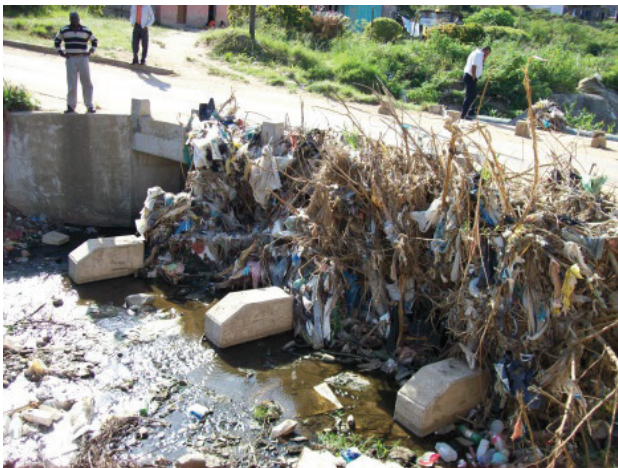
FIGURE 14 Molife Road debris walls and blockage of the culvert

The principle of debris walls on multicellular culverts was then tested on Molife Road culvert. In this instance the debris walls were installed in line with the centre walls of the culvert and approximately one third of the height of the opening. This did not prove successful as seen in the photographs below.

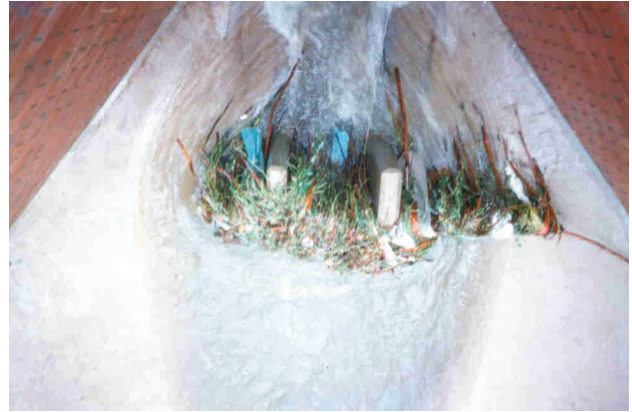
FIGURE 13 Close up of debris walls at Dipdale Road culvert

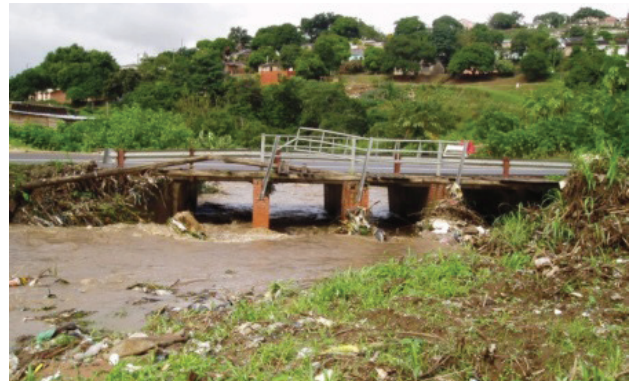
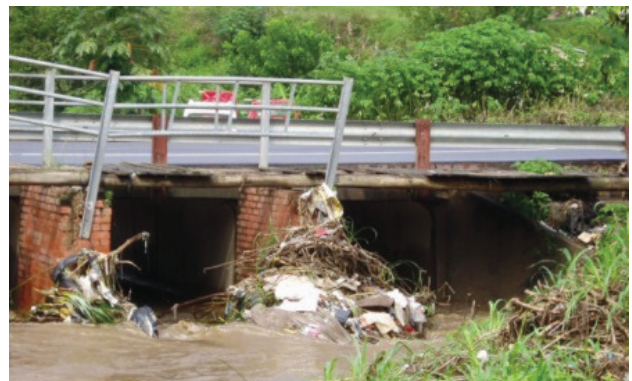
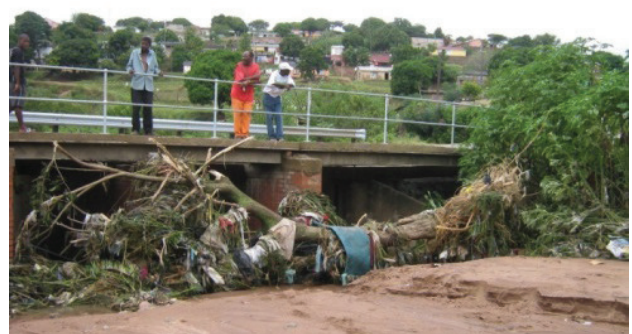
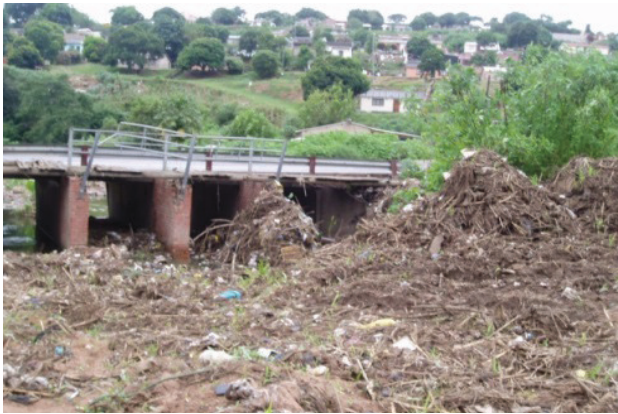
FIGURE 15 Mugabe Road culvert with debris build up

FIGURE 16 Mugabe Road culvert with debris build up

FIGURE 17 Mugabe Road culvert with debris build up – Note the build-up of silt upstream of the culvert

FIGURE 18 Mugabe Road culvert with debris build up

The Mugabe Road multicellular culvert crossing carried a major bus route across the Isipingo River. As can be seen from figures 12 to 17, this crossing was prone to blockages and subsequent closure of the road. The impact on the community was large in that the travel time to the workplace was increased by at least 20 minutes and this was associated with an increase in travel costs in what is essentially a

poor community. As can be seen, the primary cause of the overtopping was the collection of debris on the centre walls of the culvert and hence this site was seen as the ideal place to test this new idea in the use of debris walls separated from the crossing.

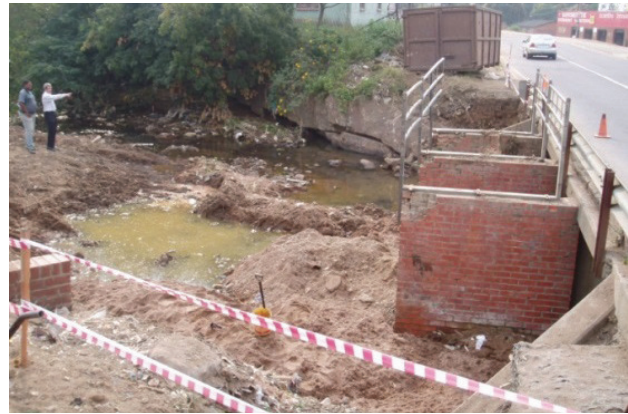
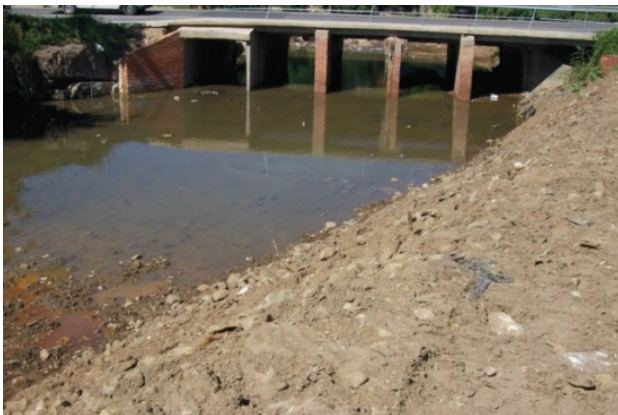
FIGURE 19 The upstream silt in the process of being removed

FIGURE 20 The upstream silt has been removed and the additional cell added

by the Municipality viz. a 1 in 10 year flood. It was decided to increase the crossing with an additional cell the same size as the existing cells which increased the capacity to a 1 in 20 year flood flow. The project was project managed by a young technician, Mr Nicholas Ndlovu, in the Coastal, Stormwater and Catchment Management Department of the eThekweni Municipality. The first aspect of the project was the installation of the additional cell and the removal of the upstream silt build up as shown in figures 18 and 19.

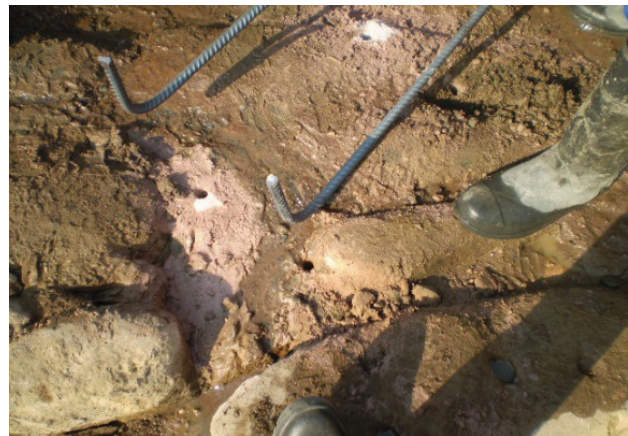
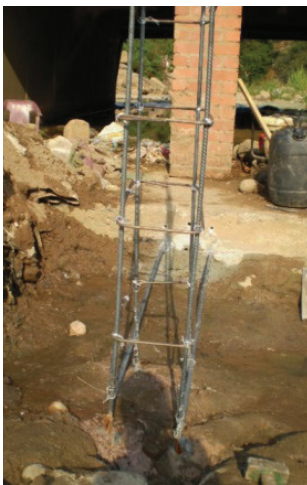
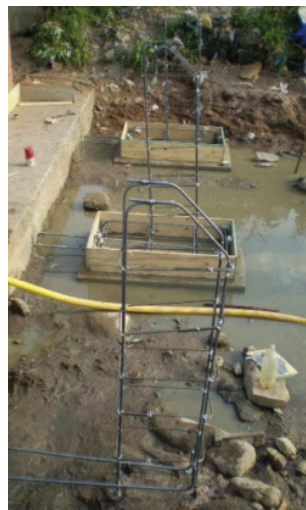
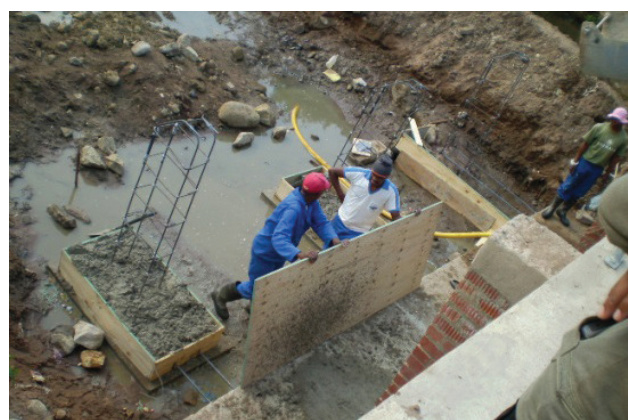
FIGURE 21 Dowel holes for reinforcement into the bedrock

FIGURE 22 Reinforcement for the debris wall dowelled into the inlet slab

FIGURE 23 Casting of the bases for the debris walls

FIGURE 24 Casting of the bases for the debris walls

The next step was to dowel the reinforcement for the debris walls into the bedrock and the existing base of the culvert inlet works

and to cast the debris walls (figures 20 to 27). These were structurally designed to withstand being fully blocked and damming water to the height of the debris walls.

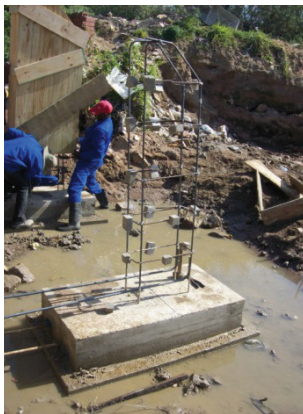
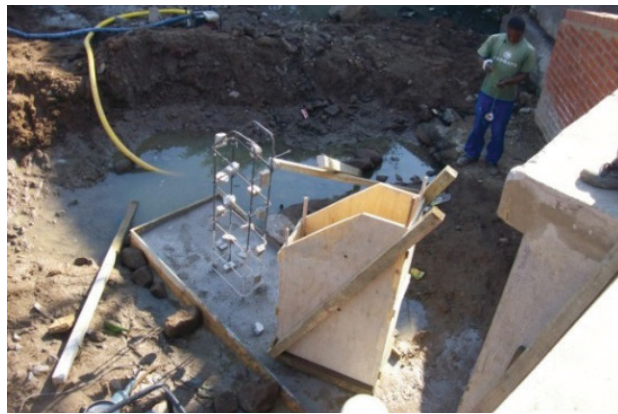
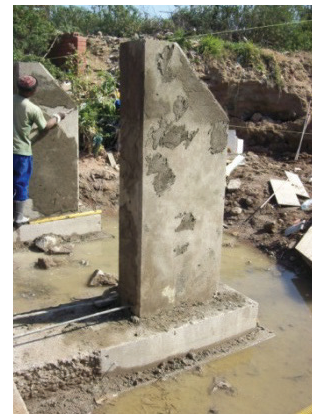
FIGURE 25 Base cast for the debris walls

FIGURE 26 Formwork for the debris walls

FIGURE 27 Debris walls cast

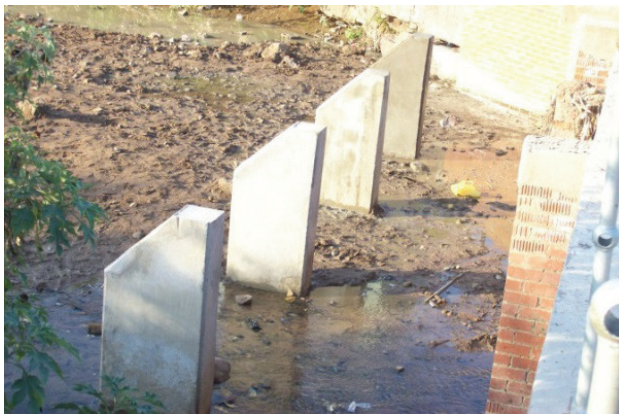
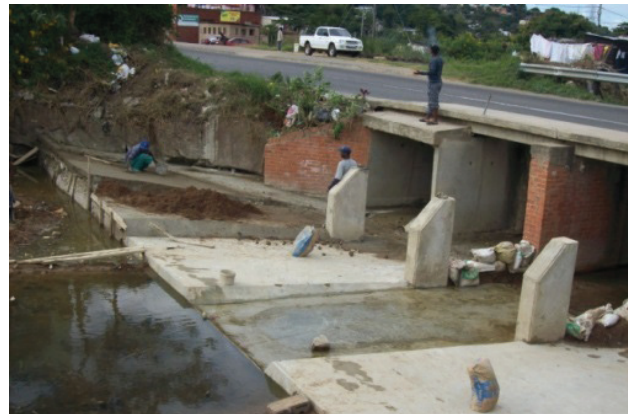
FIGURE 28 Completed debris walls

FIGURE 29 Completed debris walls

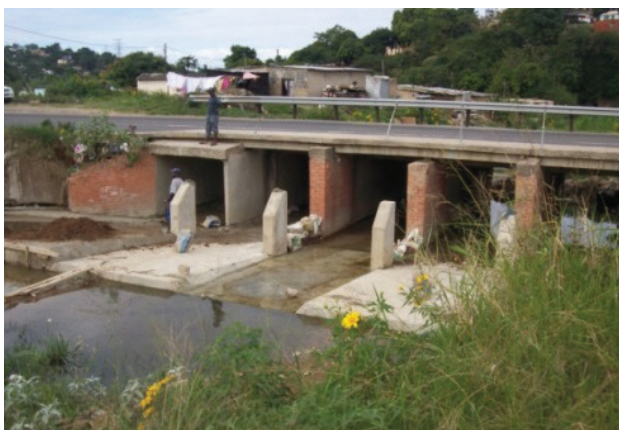
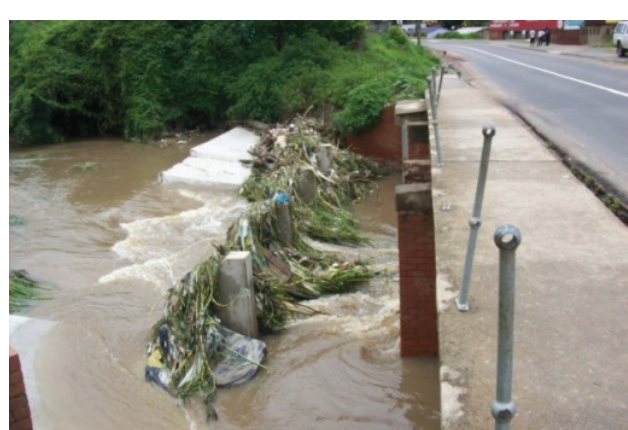
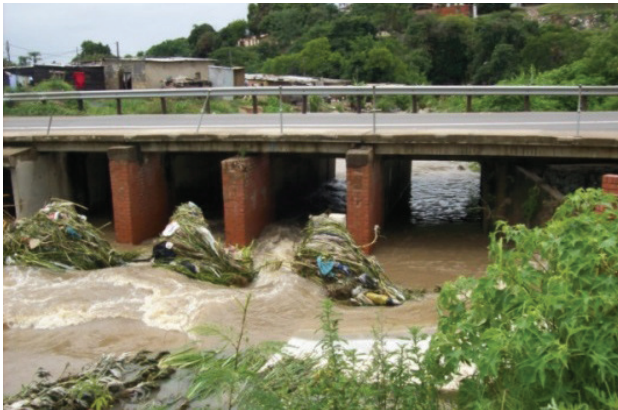
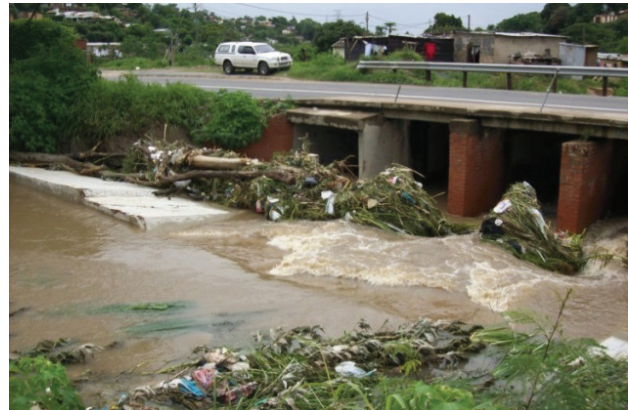
FIGURE 30 Approach slab enhancement

FIGURE 31 Debris walls in action after a storm

FIGURE 32 Debris walls holding debris - note the acceleration of water towards the centre of the downstream cell

FIGURE 33 Debris including a large tree trunk collected by the debris walls - note that there is no debris on the culvert centre walls

The apron slab for the culvert crossing was enhanced to focus the low flow through the centre cell of the culvert and to accelerate the water through the culvert during high flows to assist with keeping the culvert free of silt as shown in figures 28 and 29. The acceleration of the water between the debris walls means that any debris that passes the debris walls is pushed to the centre of

the downstream culvert opening and passes through the culvert. Furthermore branches or poles which do not span between debris walls but only hit one of the debris walls are turned to align with the culverts and pass harmlessly through the culvert (figures 30 to 33).

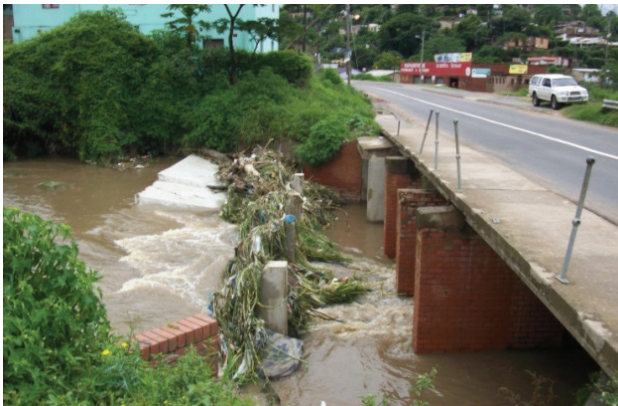
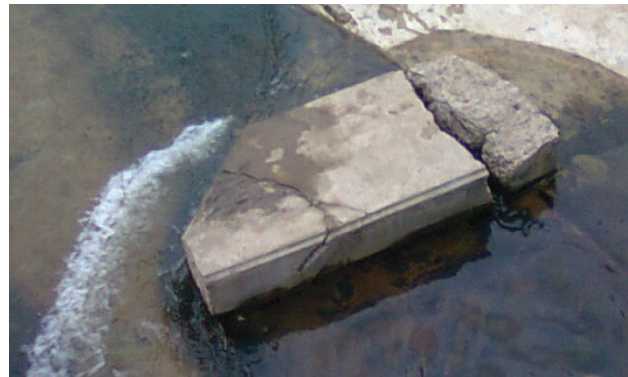
FIGURE 34 Side view of the debris wrapped around the debris walls

FIGURE 35 Debris wall broken by excavator during the clearing of the debris

The debris walls although effective in stopping the debris from clogging the culvert opening, still needed to be cleaned by the maintenance teams. In this instance, the maintenance team was not briefed on the functioning or cleaning of these debris walls and when using an excavator to clear the debris one of the debris walls

was broken by the excavator (figure 34). This incident highlighted the need for cleaning teams to understand how the debris walls were designed to function and the care needed in clearing them. While the debris wall was missing another storm event occurred and it was interesting to see the debris immediately built up on not only the centre wall downstream of the broken debris wall but also the two adjacent centre walls (figures 35 and 36). This highlighted the impact the debris walls had on the streamlines through the culvert and the effectiveness of the debris walls.

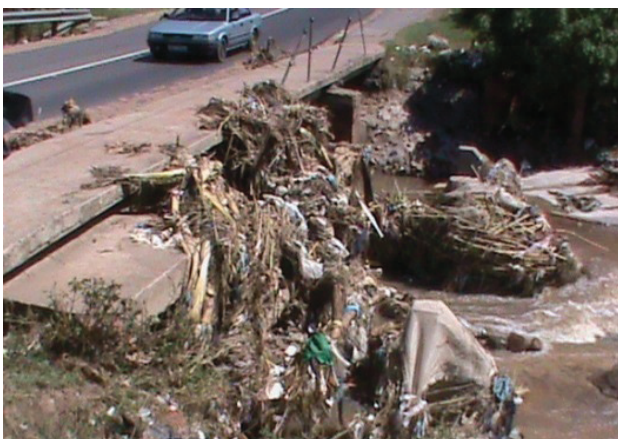
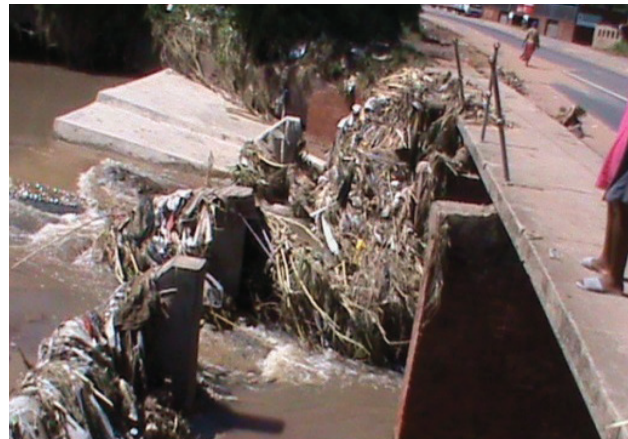
FIGURE 36 Debris build up while the one debris wall was missing

FIGURE 37 Debris build up while the one debris wall was missing
