## APPLICATION OF CONDITION ASSESSMENT PRINCIPLES TO THE BLACKMAC SEWER

**Alaster Goyns****Owner Pipeline Installation and Professional Engineering Services CC****ABSTRACT**

This approach was applied to a 7.8 kilometre section of the Blackmac outfall sewer across the Cape Flats, consisting of 800 to 1 000 mm diameter coated fibre cement pipes installed during 1983. Most of the upstream 3.8 kilometres had sufficient capacity for the required flow and adequate structural integrity. The downstream section had been de-commissioned, had inadequate capacity and sections were severely corroded. A remaining life analysis indicated that sections had collapsed. At the end of 2016 contracts for rehabilitating and replacing sections of this sewer were awarded.

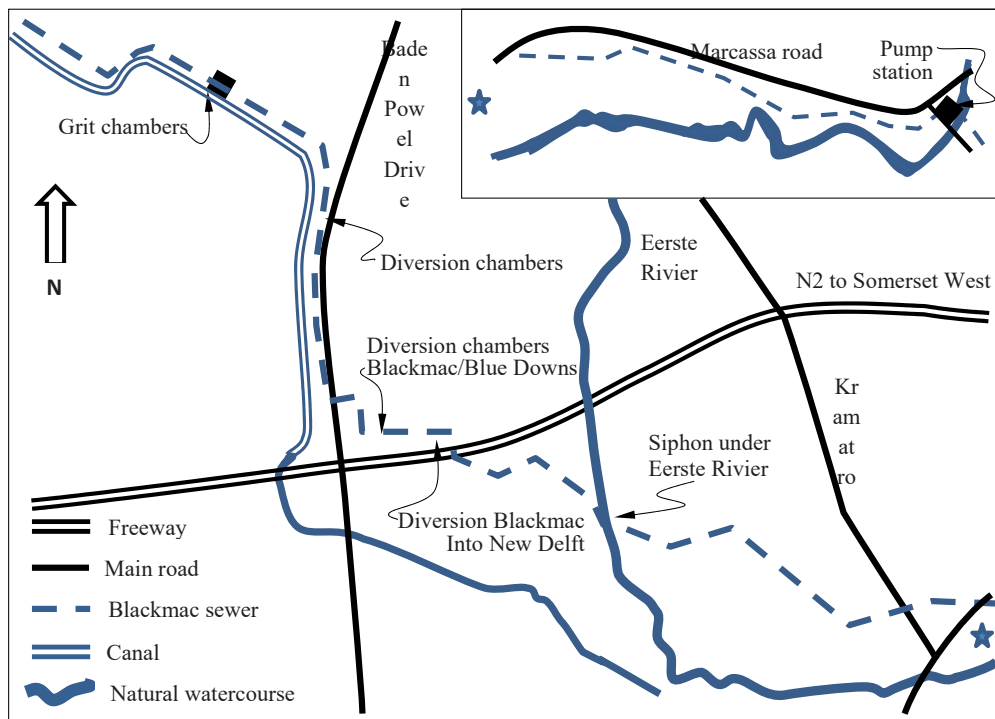
**FIGURE 6:** Schematic layout of Blackmac outfall sewer showing location of main features

From the desktop study, including reference to Google Earth, various topographic features were identified (see Figure 6) that could influence decisions about replacing or re-routing sections of the sewer.
